BUREAU OF SHIPS GROUP TECHNICAL INSPECTION REPORT

OPERATION CROSSROADS. U.S.S. INDEPENDENCE (CVL22)

TEST ABLE

VOLUME 1 OF 4 [U].

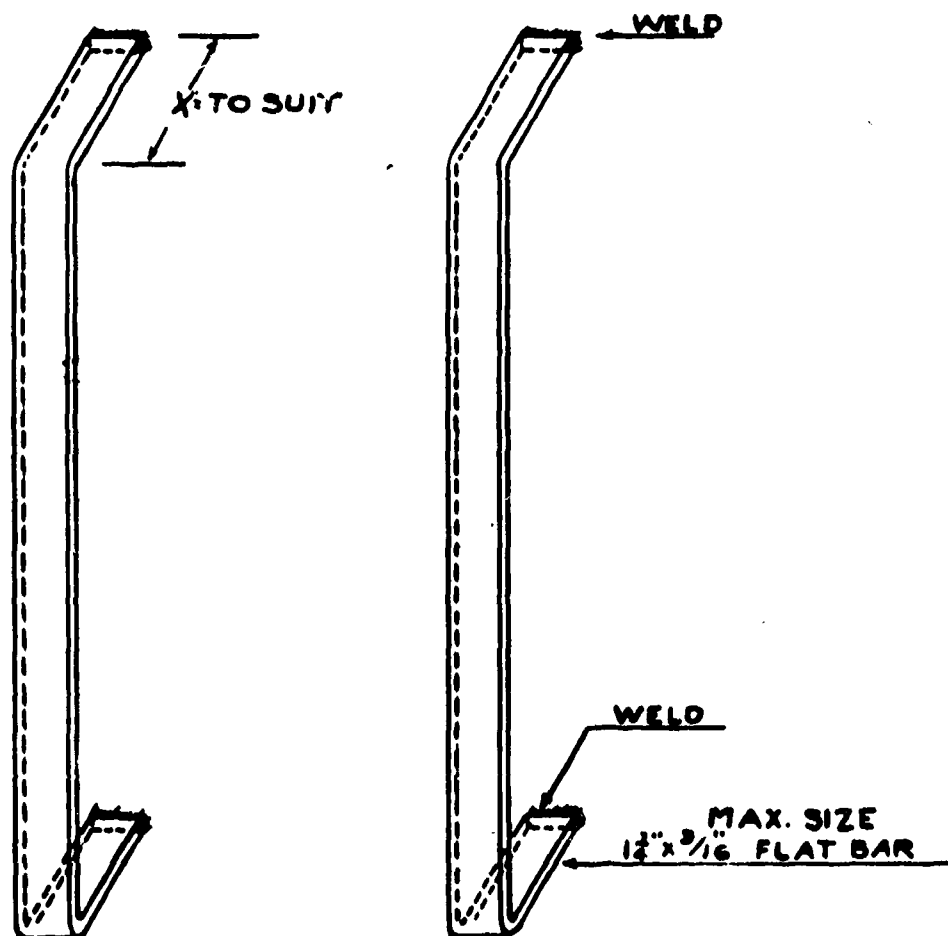
SKETCH CR-2E

TYPICAL FOUNDATION FOR
JUNCTION, CONNECTION AND DISTRIBUTION BOXES
WHEN MOUNTED ON BHDS. LESS THAN 1/2" THICK

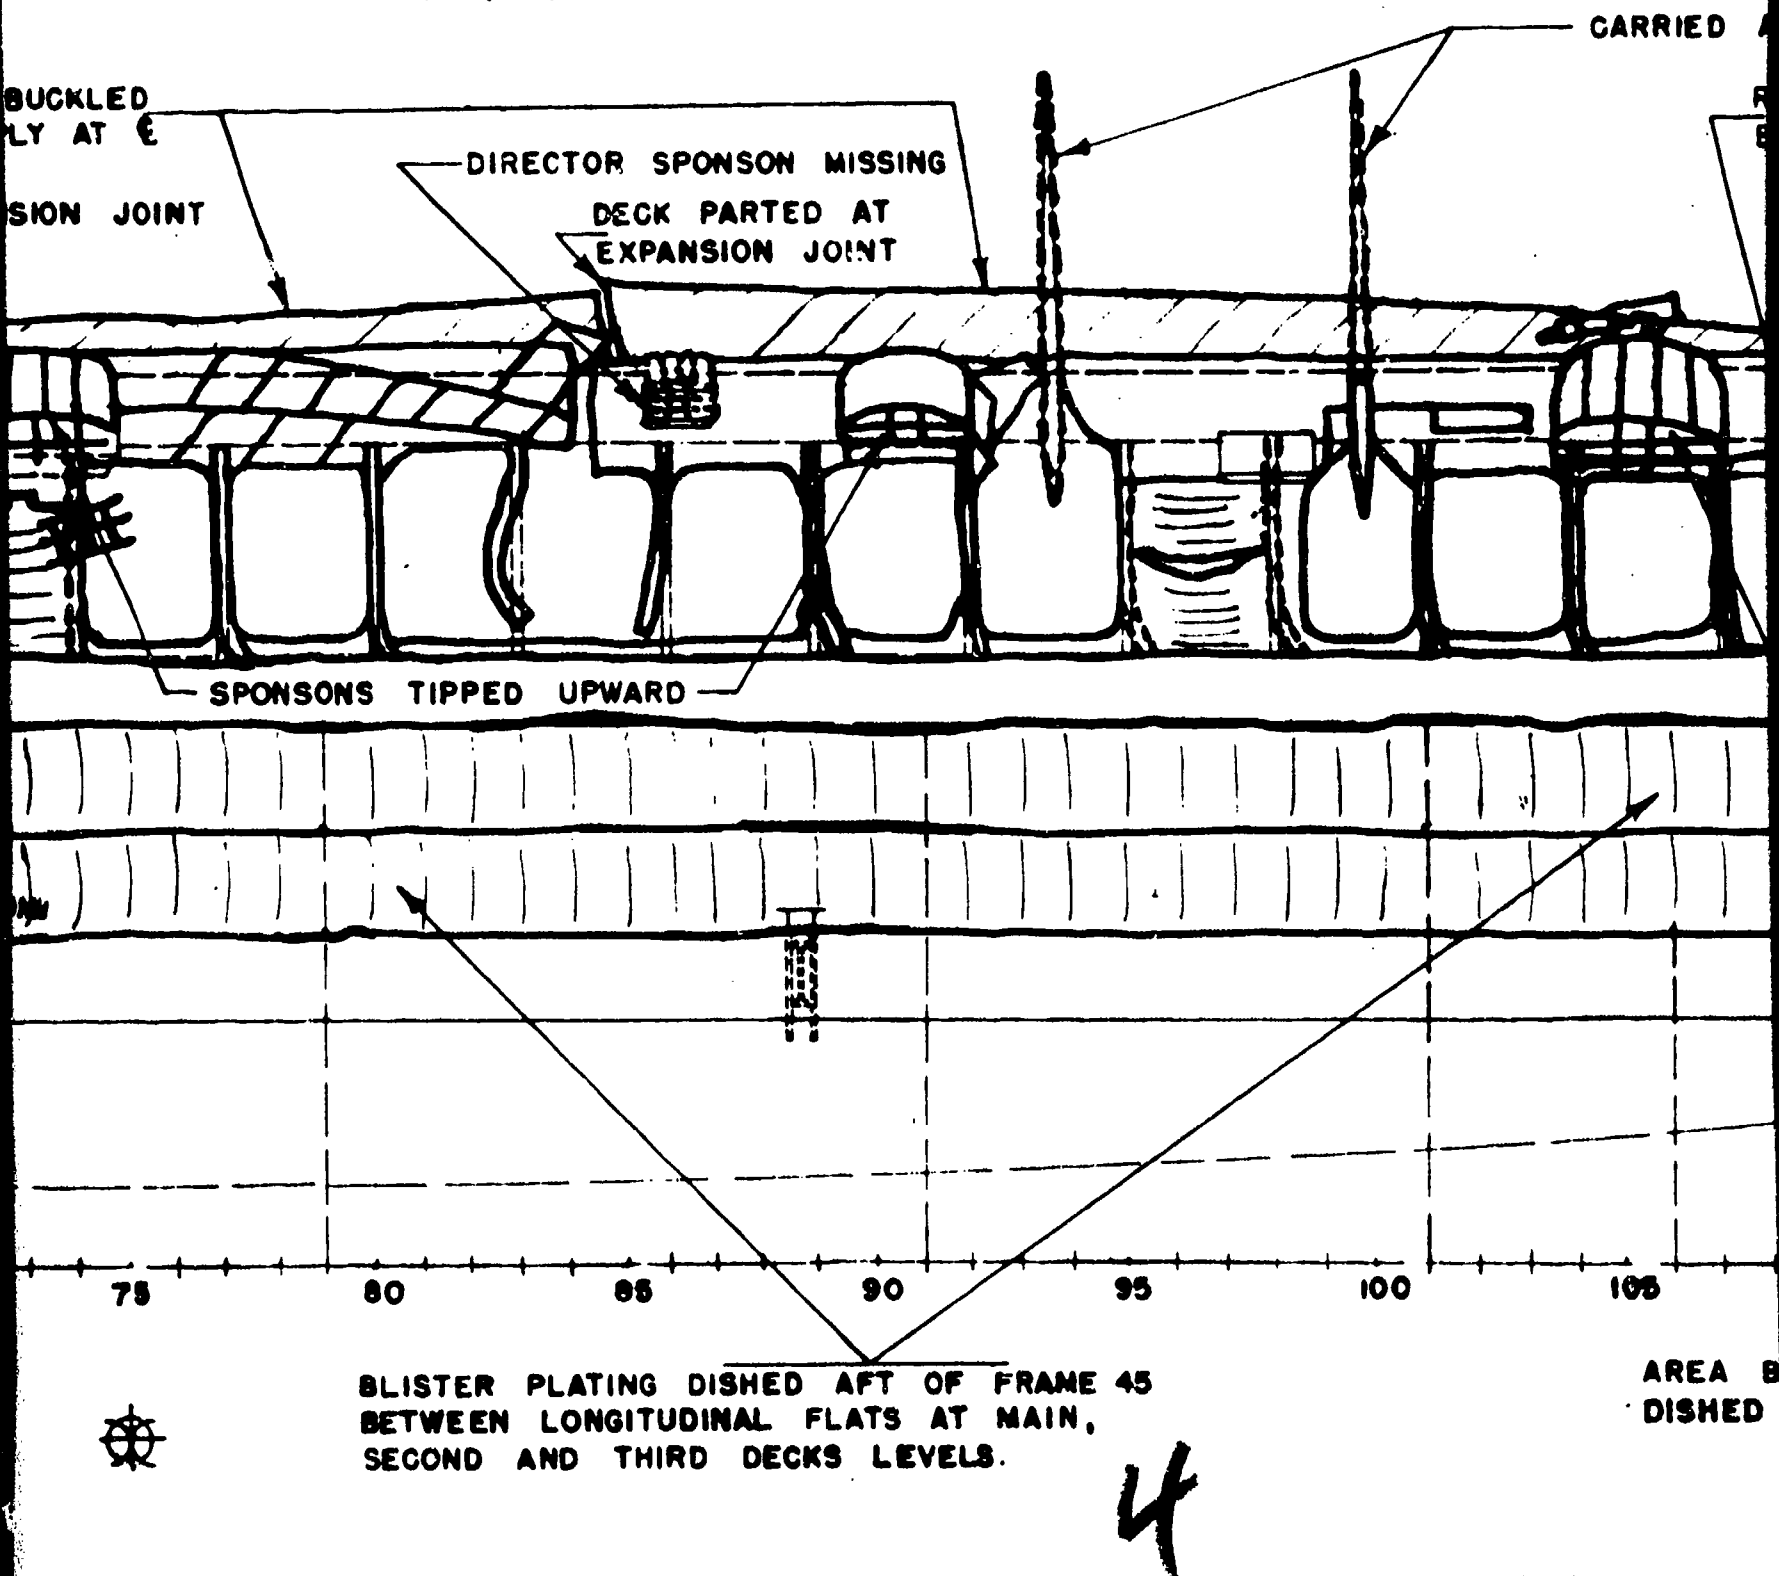
PANELS BETWEEN FLIGHT DECK BENTS
FRAMES 56 TO 71, 74 TO 95, 98 TO 107,
AND 110 TO 118 CARRIED AWAY IN-
BOARD BY BLAST. WOBBLE BENTS
ADJACENT TO EXPANSION JOINTS TORN
AWAY FROM CONNECTION TO HANGAR DECK.
(FRAMES 62, 65, 83, 86, 110 AND 113).

ROLLER CURTAINS CARRIED AWAY
TO STARBOARD BY BLAST.

CARRIED AWAY BY BLAST

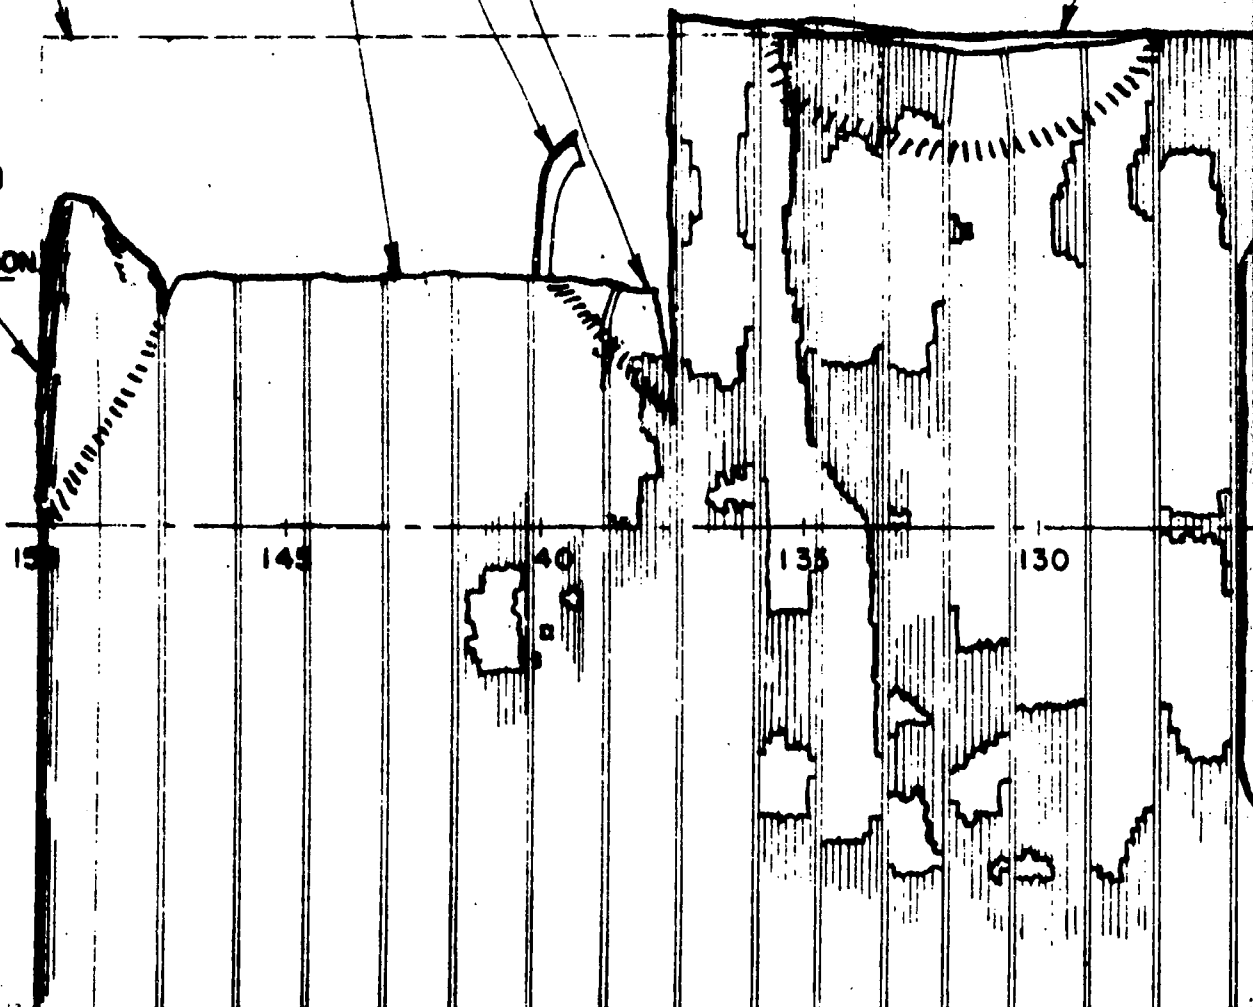
PORTION OF DECK TORN
AND BENT UPWARD.

FLIGHT DECK BADLY WARPED AND
WOOD DECKING BURNED FROM FIRE
BELOW.

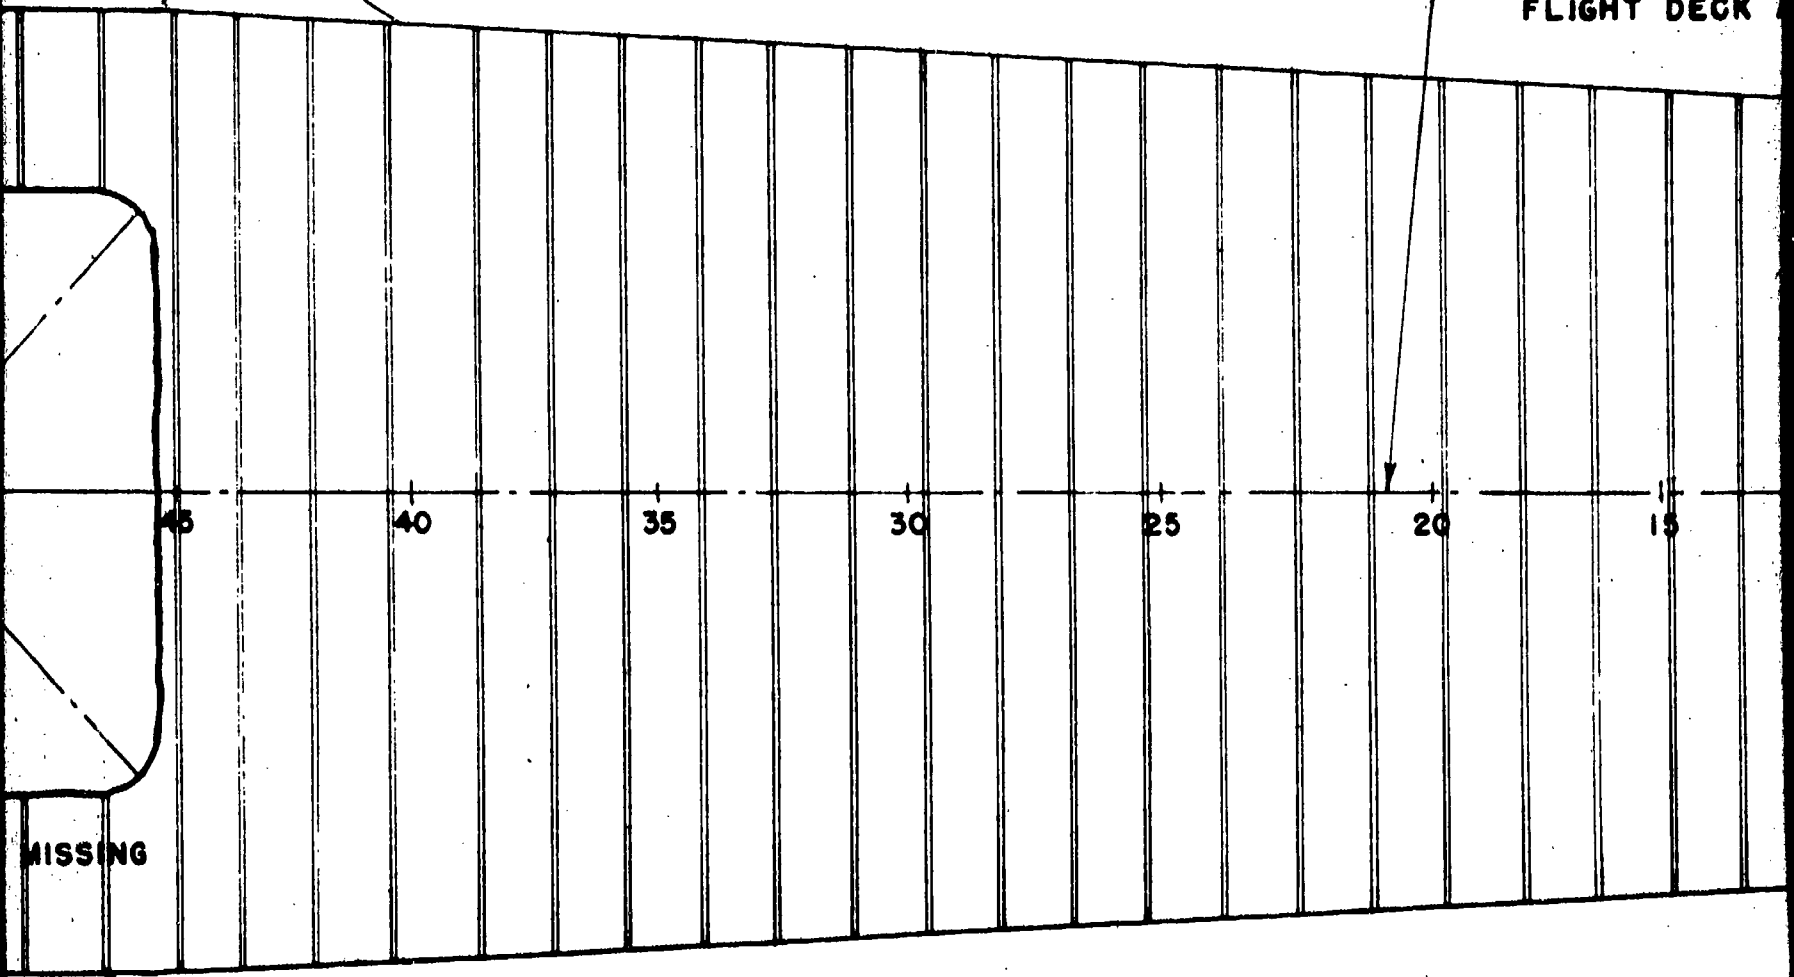
FLIGHT DECK ABREAST AND FORWARD OF FORWARD ELEVATOR IS SLIGHTLY DISTORTED BUT ESSENTIALLY UNDAMAGED.

CRANE IS OFF ROLLER PATH
ISLAND SEVERELY DAMAGED AND TOP-HAMPER MISSING

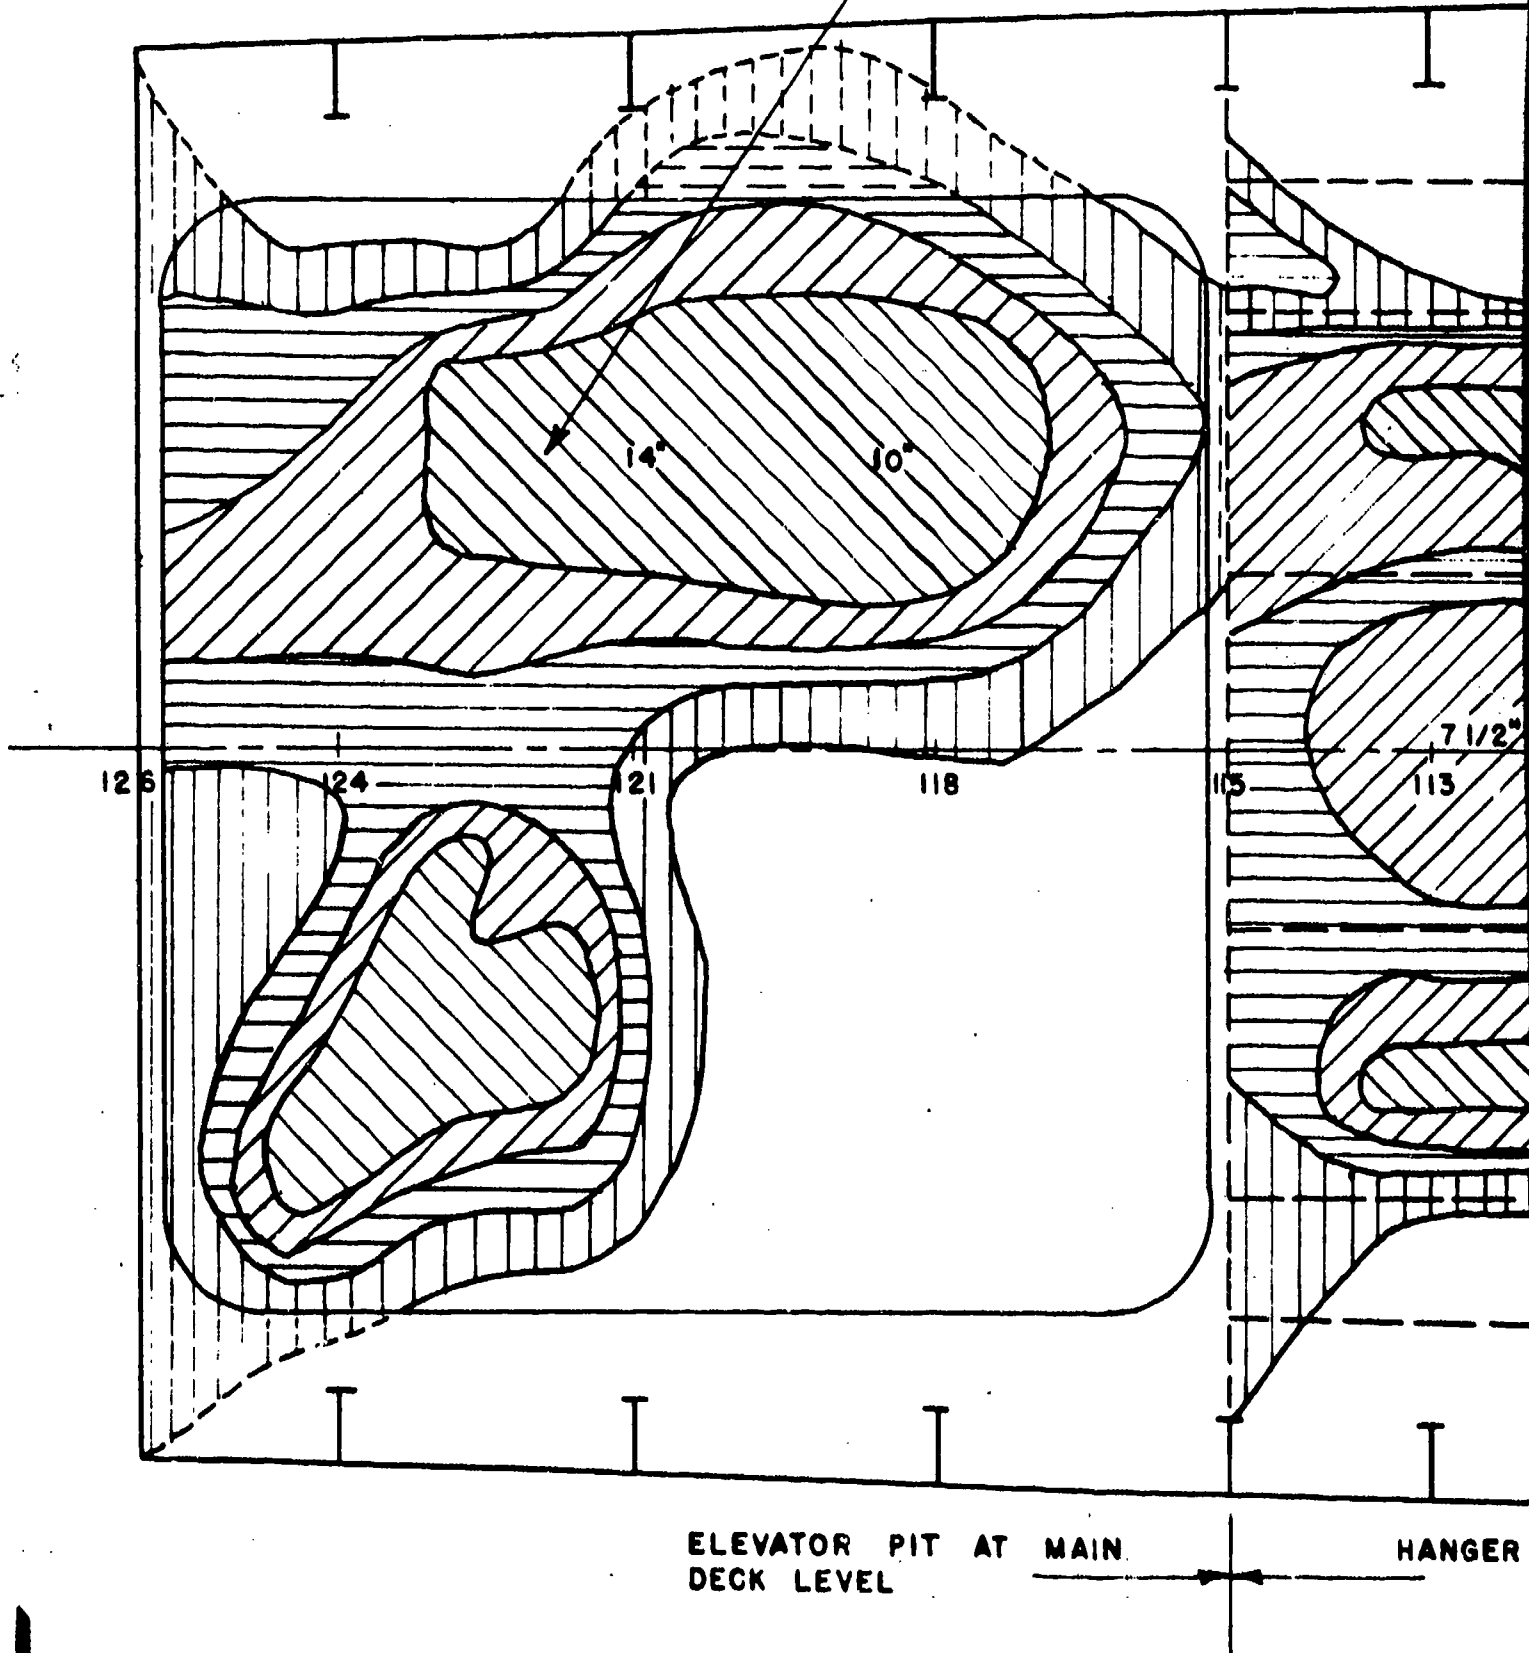
TRANSVERSE BEAM FAILED BE
MAIN DECK FRAME 122.

FAILED BELOW
122 .

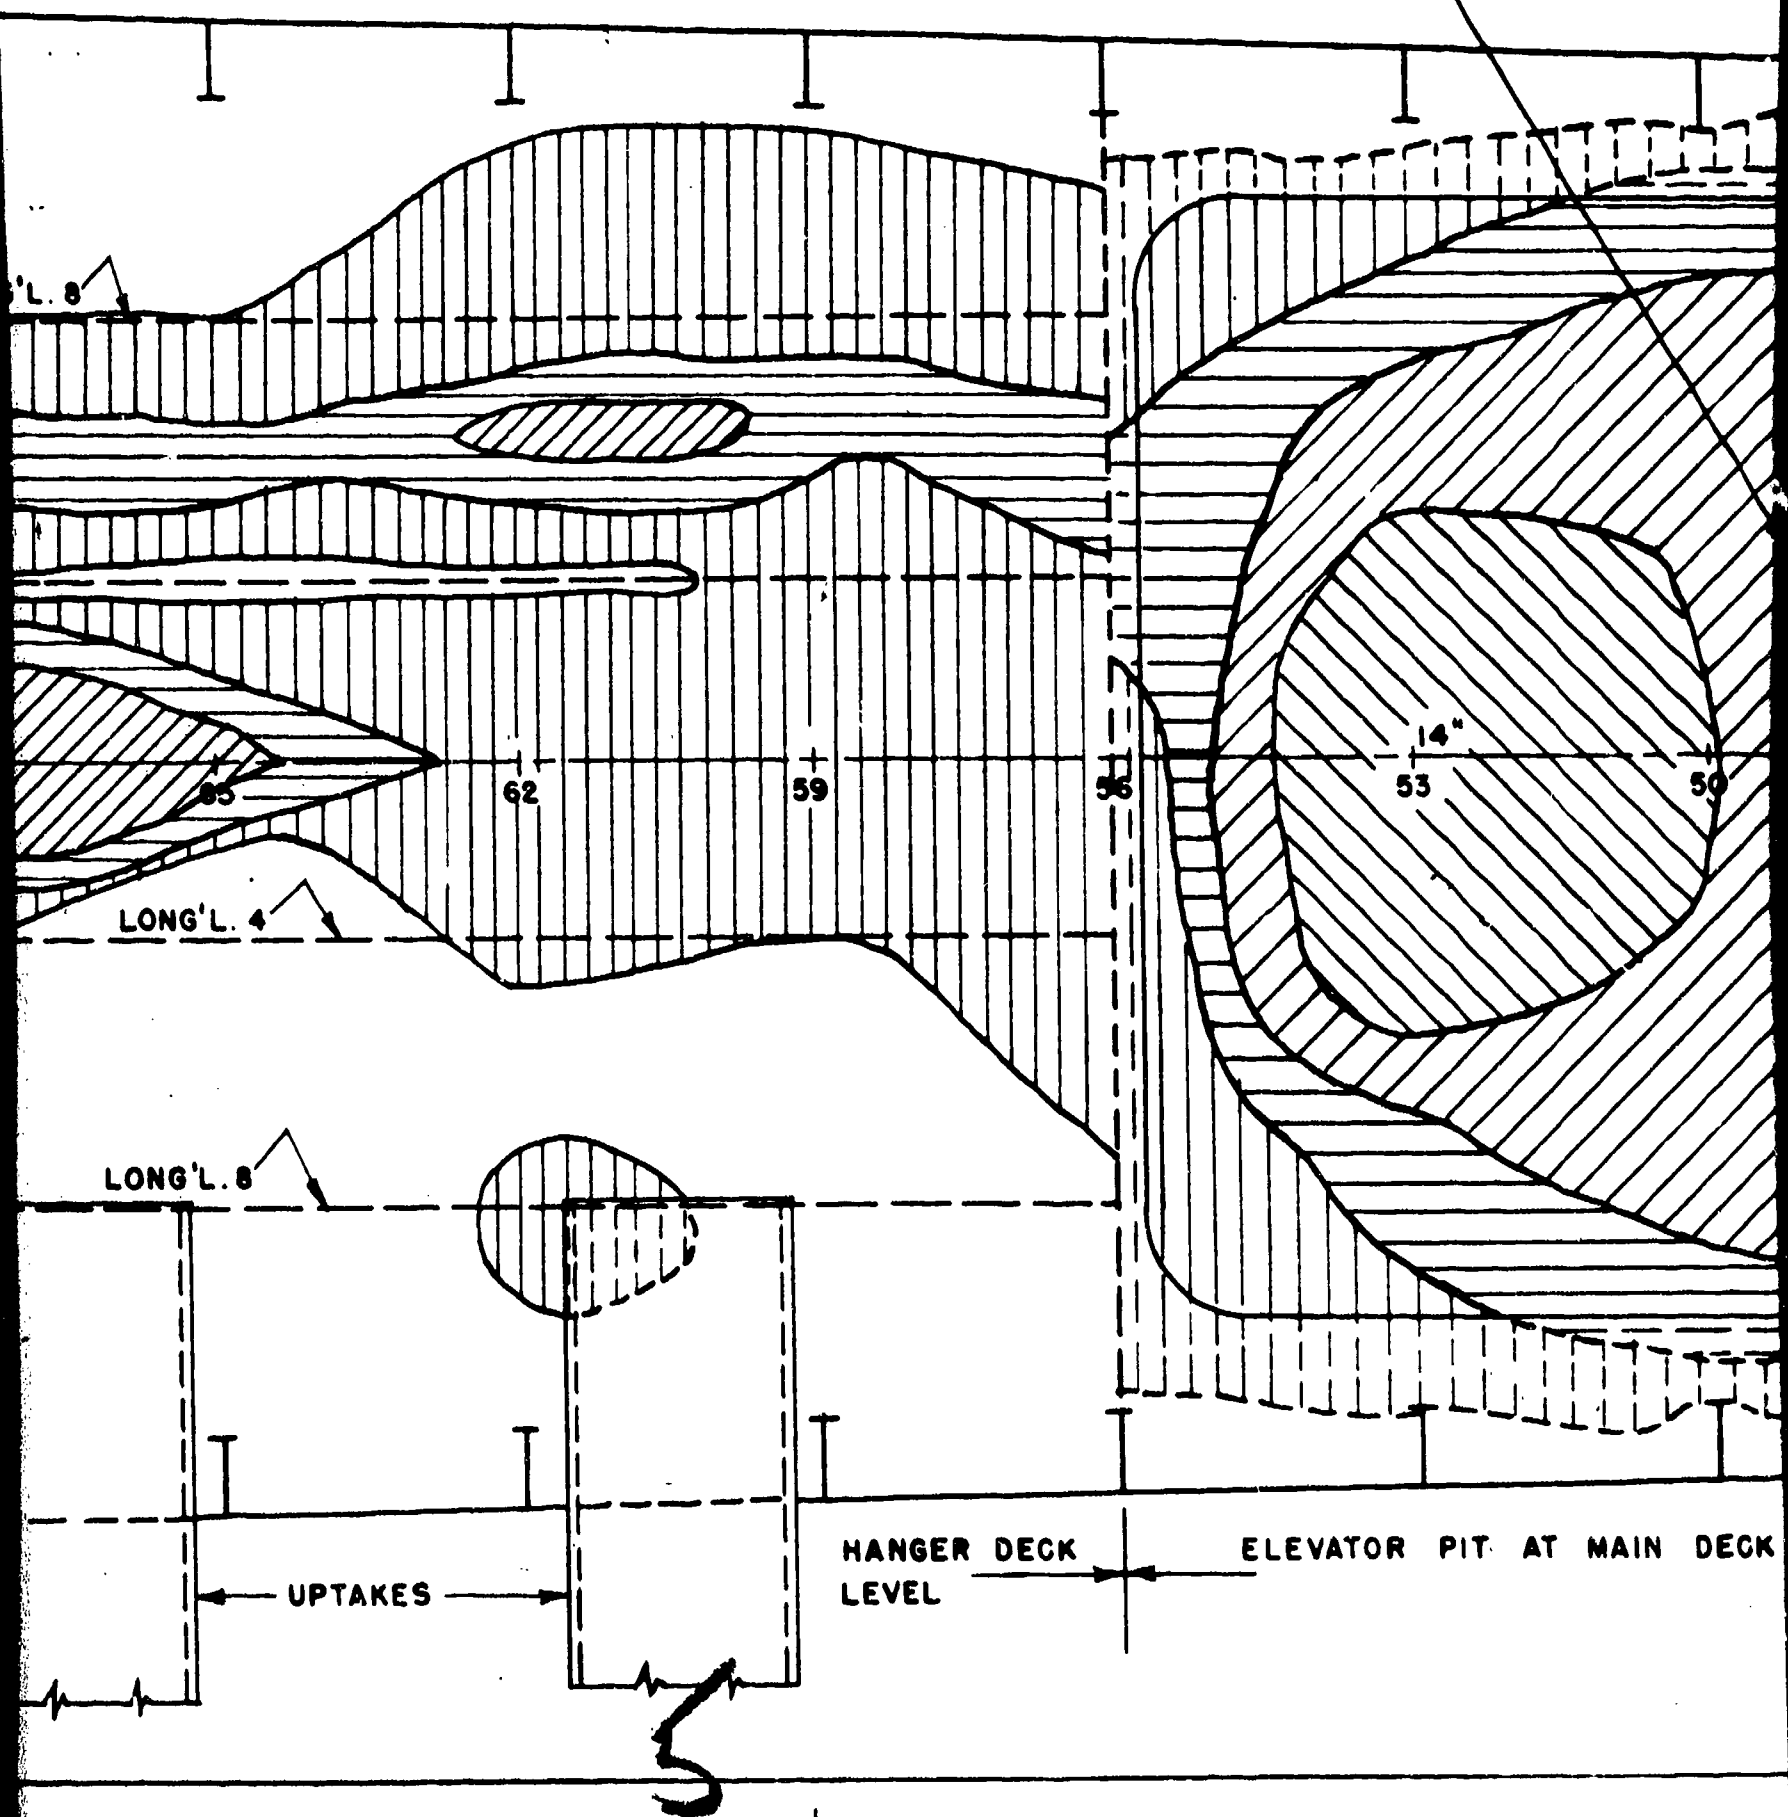
IN WAY OF RIVETED CONNECTION
SIDE OF MAIN DK. OVER BHD. 49.

FAILURE IN WELDED BUTT
IN MAIN DECK.

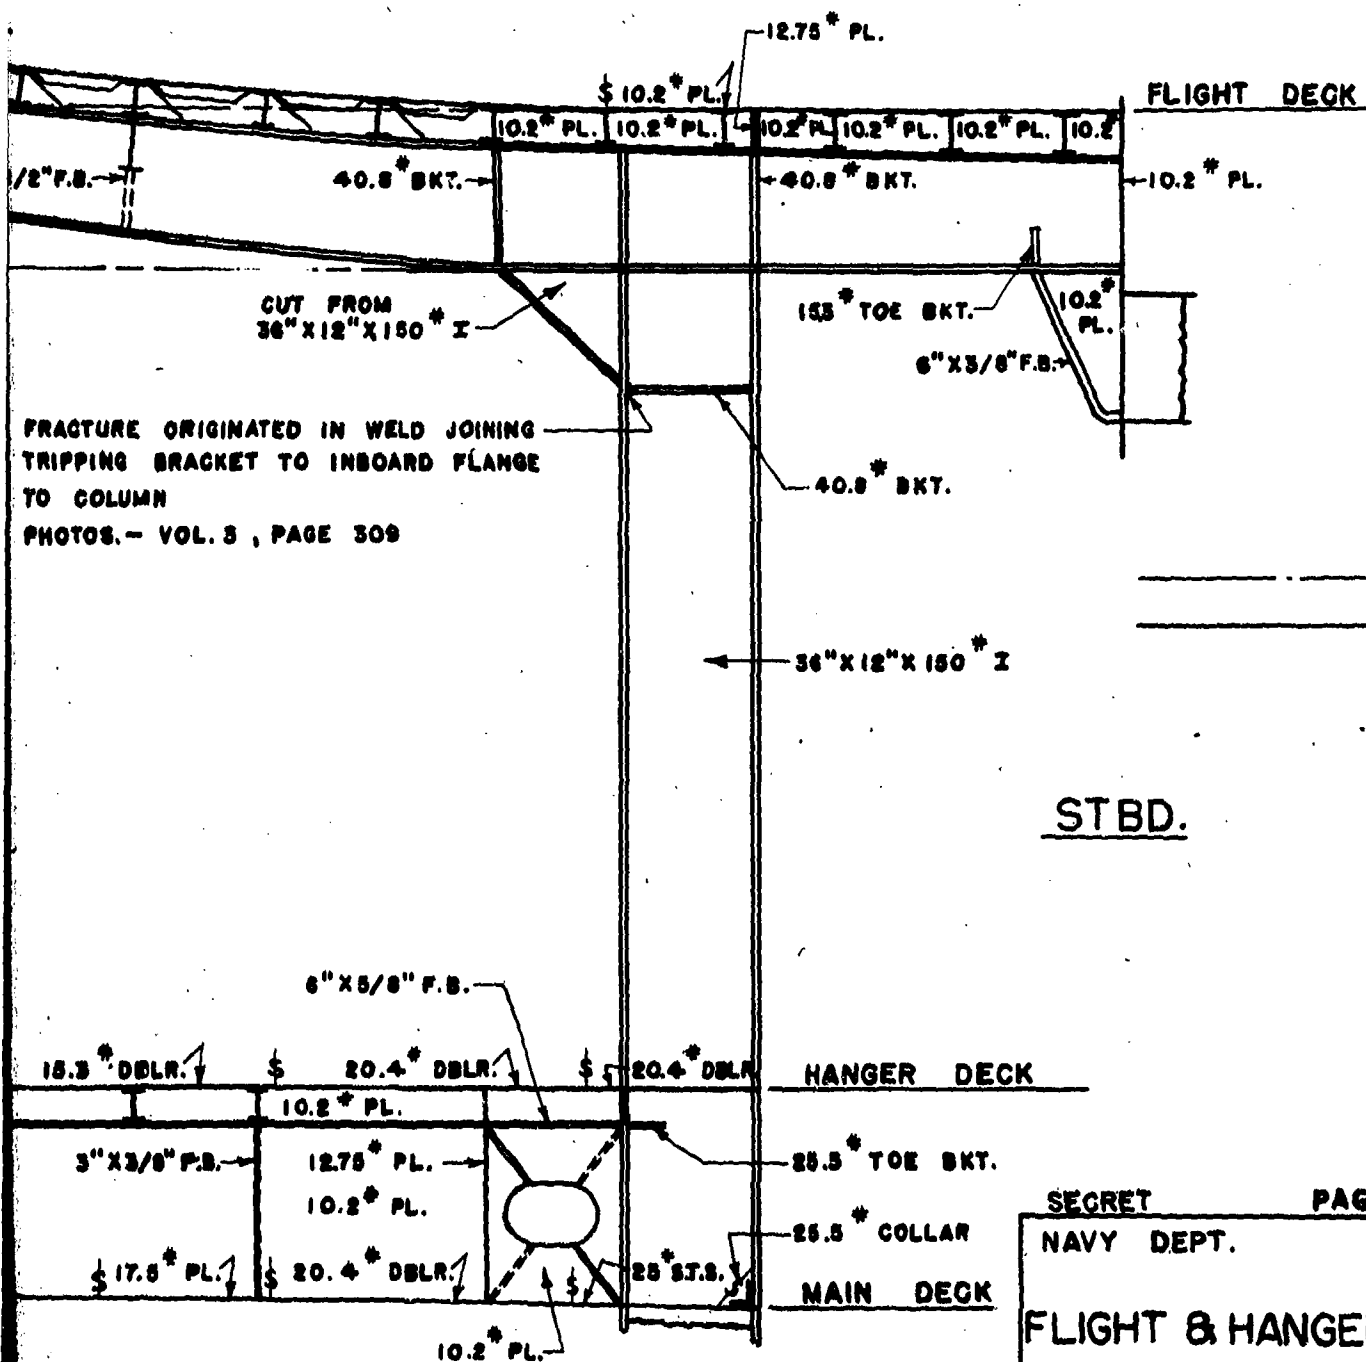
TRANSVERSE SECTION AT FR. 59
 LOOKING FORD.

FRACTURE ORIGINATED IN WELD JOINING
 TRIPPING BRACKET TO INBOARD FLANGE
 TO COLUMN
 PHOTOS. - VOL. 3, PAGE 309

FRACTURE ORIGINATED IN WELD JOINING
TRIPPING BRACKET TO INBOARD FLANGE
TO COLUMN
PHOTOS.— VOL. 3, PAGE 309

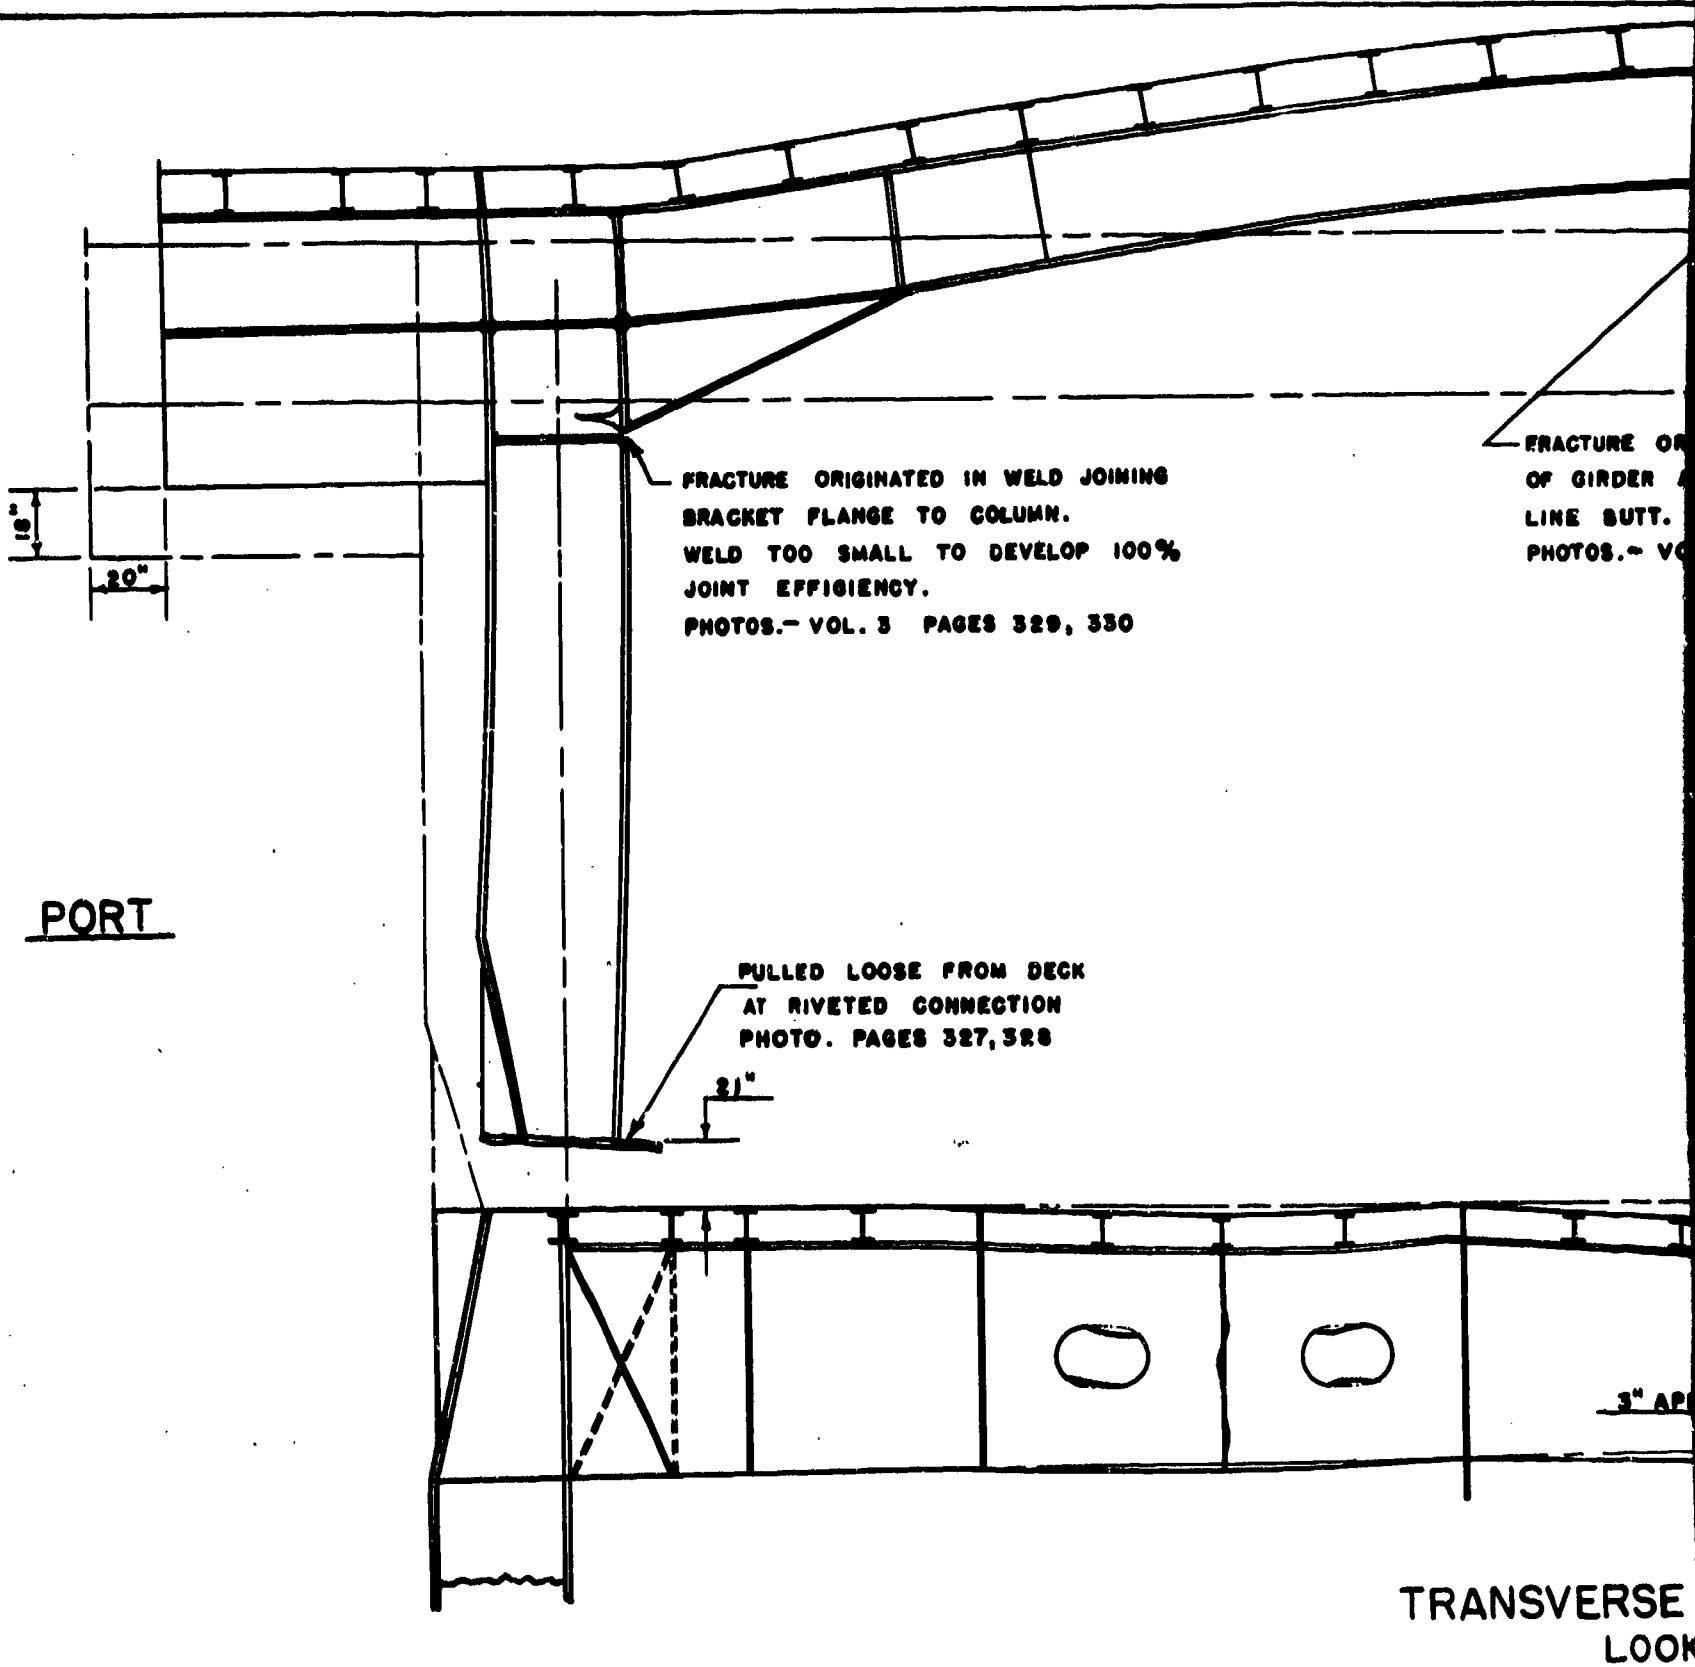
FRACTURE ORIGINATED IN LOWER FLANGE
OF GIRDER AT EDGE OF WELDED CENTER-
LINE BUTT.
PHOTOS.- VOL. 3 PAGES 320, 323, 326

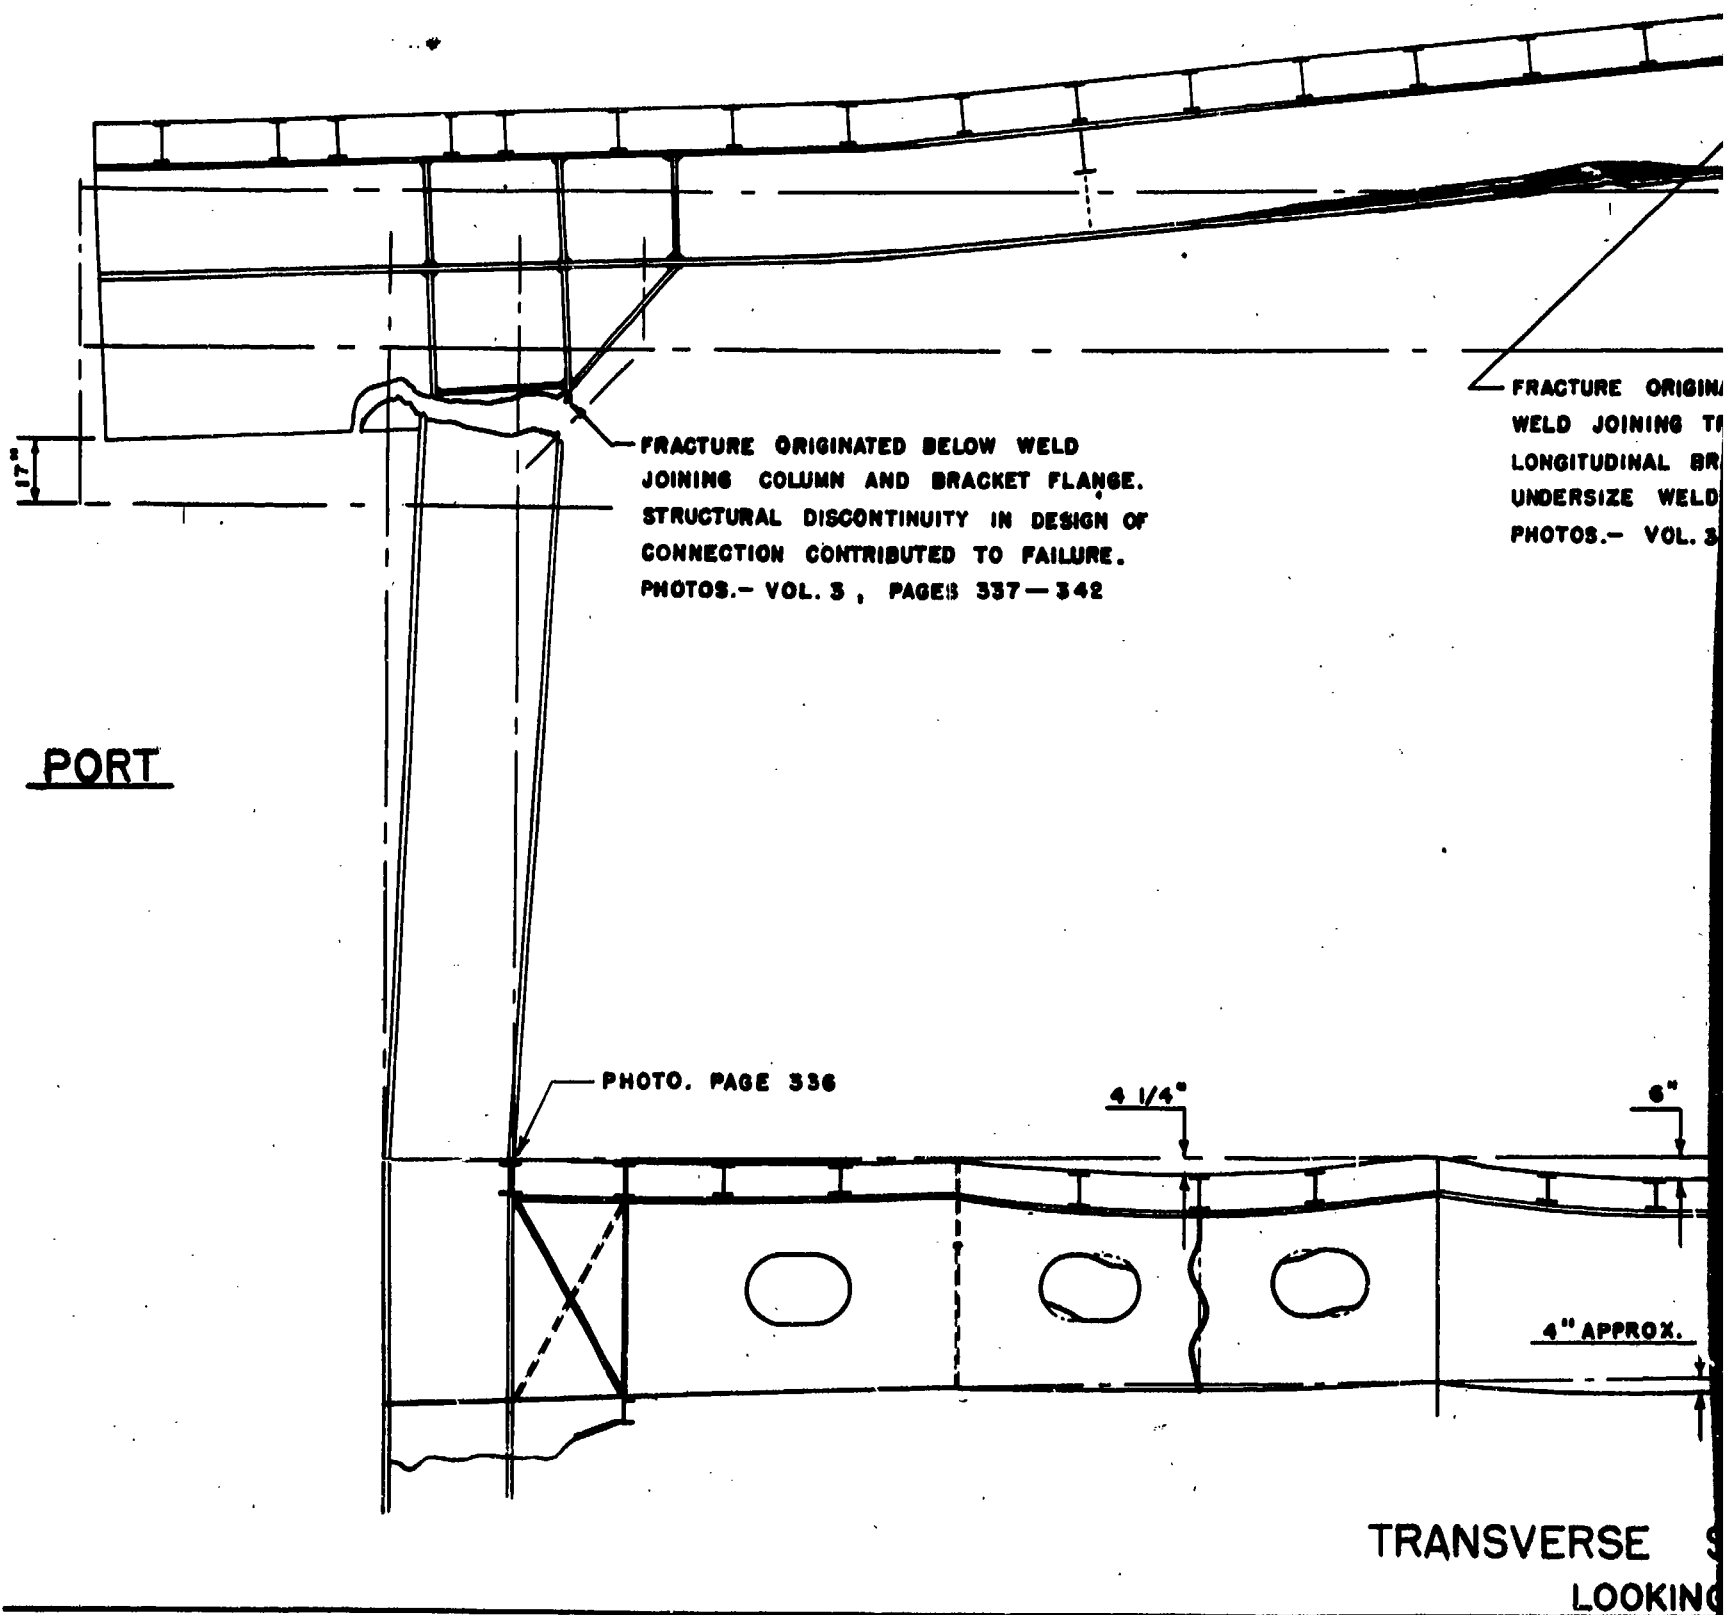
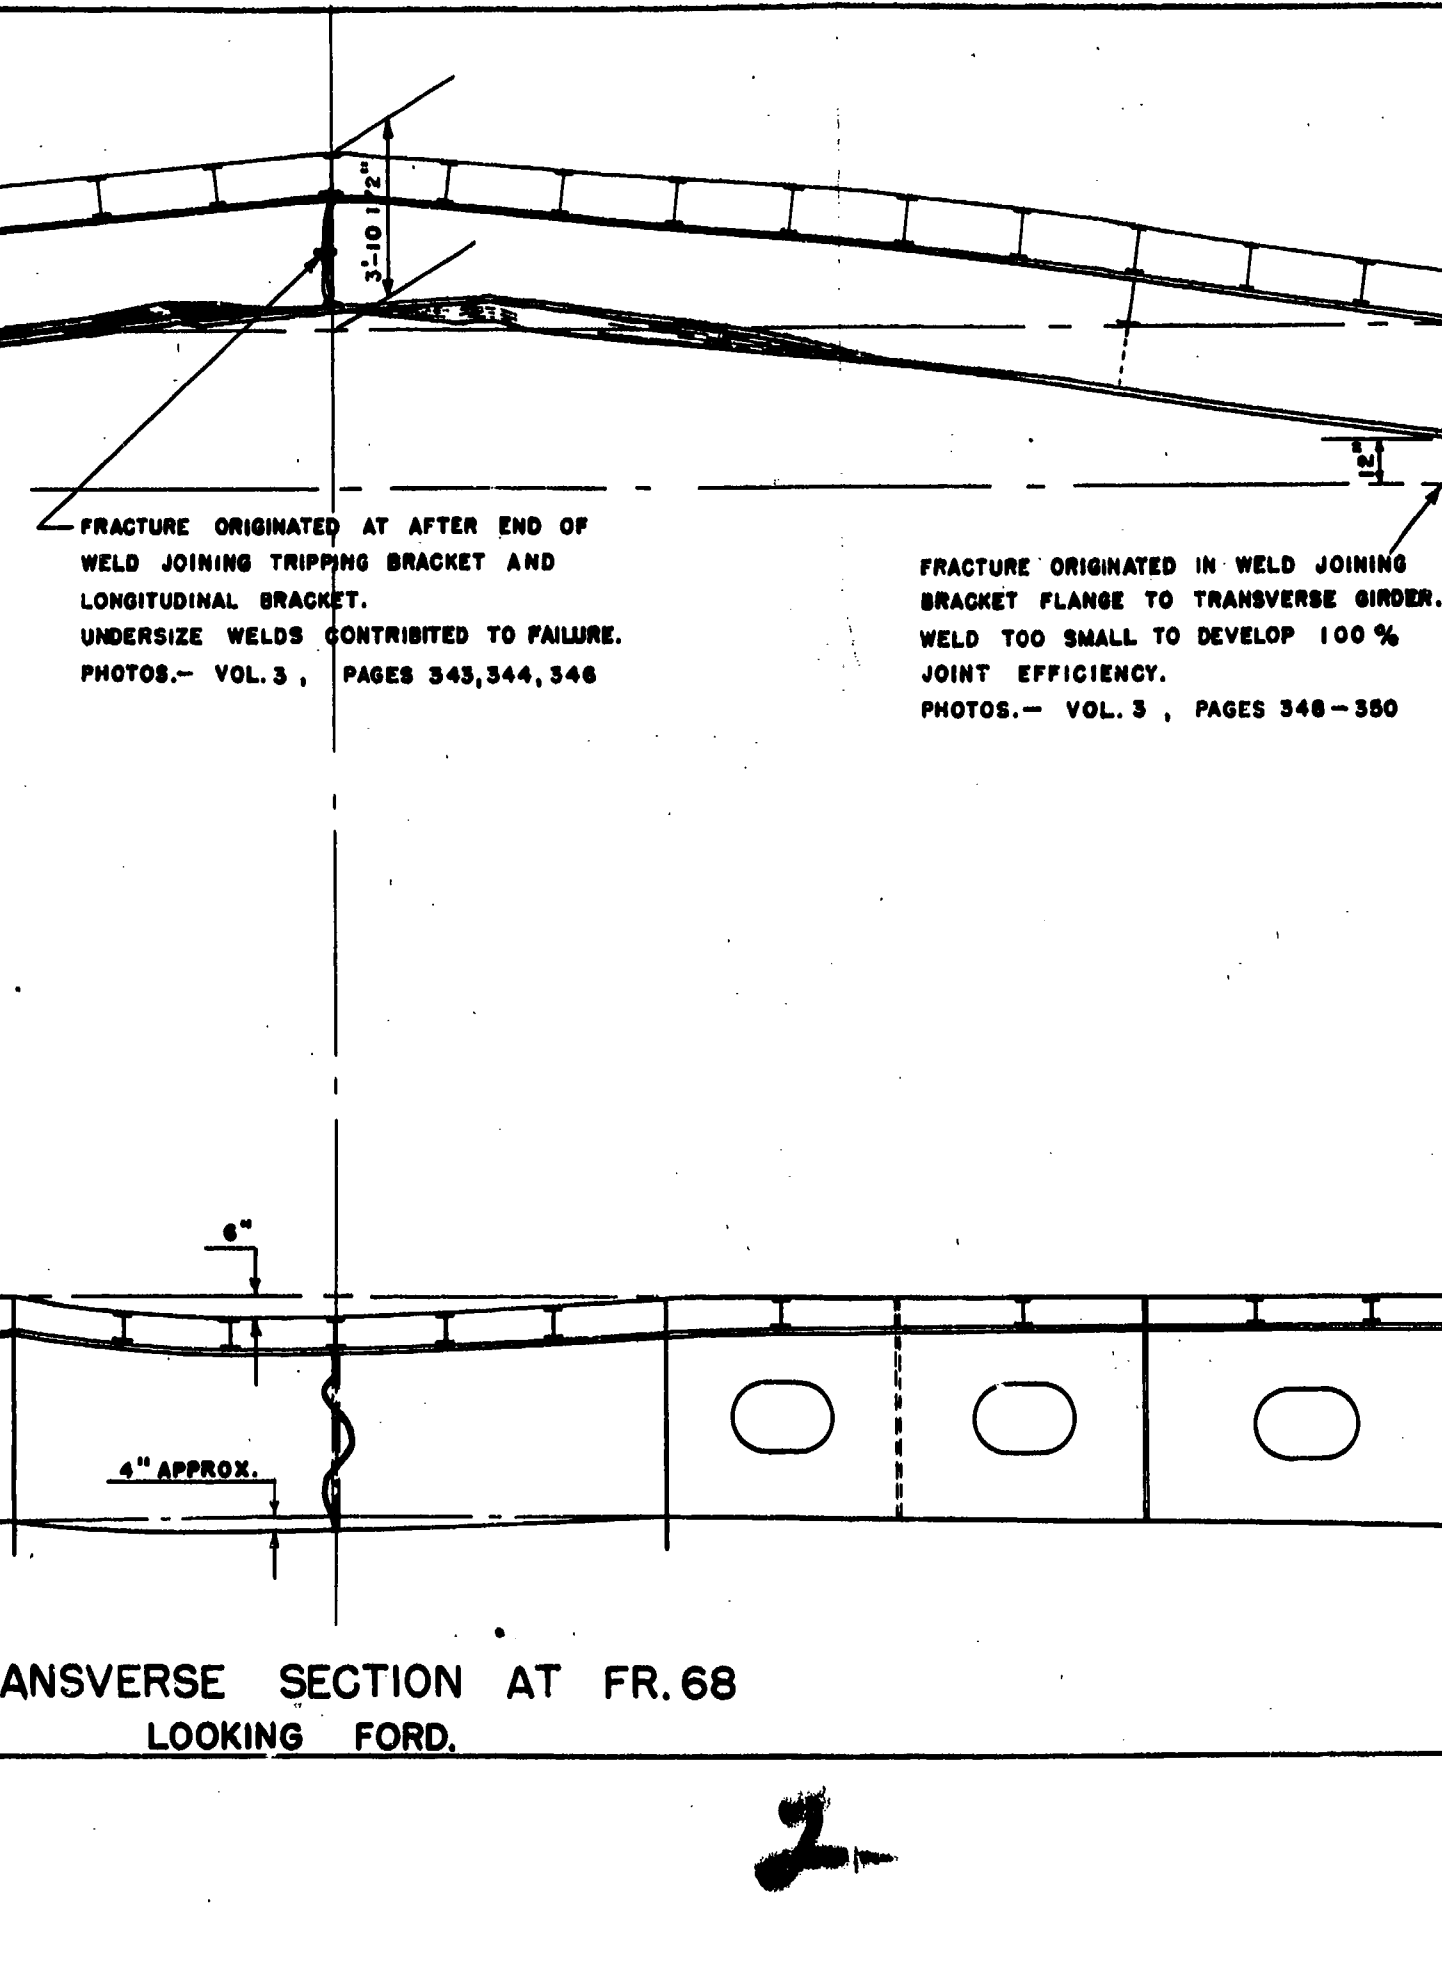
TRANSVERSE SECTION AT FR.65
LOOKING FORD.

FRACTURE ORIGINATED AT AFTER END OF
WELD JOINING TRIPPING BRACKET AND
LONGITUDINAL BRACKET.
UNDERSIZE WELDS CONTRIBUTED TO FAILURE.
PHOTOS.— VOL. 3 , PAGES 343, 344, 346

FRACTURE ORIGINATED IN WELD JOINING
BRACKET FLANGE TO TRANSVERSE GIRDER.
WELD TOO SMALL TO DEVELOP 100 %
JOINT EFFICIENCY.
PHOTOS.— VOL. 3 , PAGES 346 — 350
